F/O ID	RN110797057		
F/O Name	BULLDOG ENVIRONMENTAL ANTON UNA SITE		
F/O Physical Address	213 N MAIN ST		
Location City	ANTON	Location Zip	79313
Location County	HOCKLEY	Operational Status	Active
Primary Business Activity	Environmental Clean-ups	Type of Small Entity	Small Business
SNC or HPV?	SNC	SIC Code	
Potentially Affected Area	HUMAN HEALTH AND THE ENVIRONMENT	Complaints Closed	1
List any NOV's? Orders for same or similar violations at this F/O in the past 5 years.			
Additional IDs	455020064

COMP CG_HOCKLEY_CP_20190525_INVESTIGATION
Texas Commission on Environmental Quality
Investigation Report

Activity Type(s): IHWCMPL - Complaint investigation
MSWUNA - Investigation at a site that
is in violation of 330.7, including
illegal disposal of tires

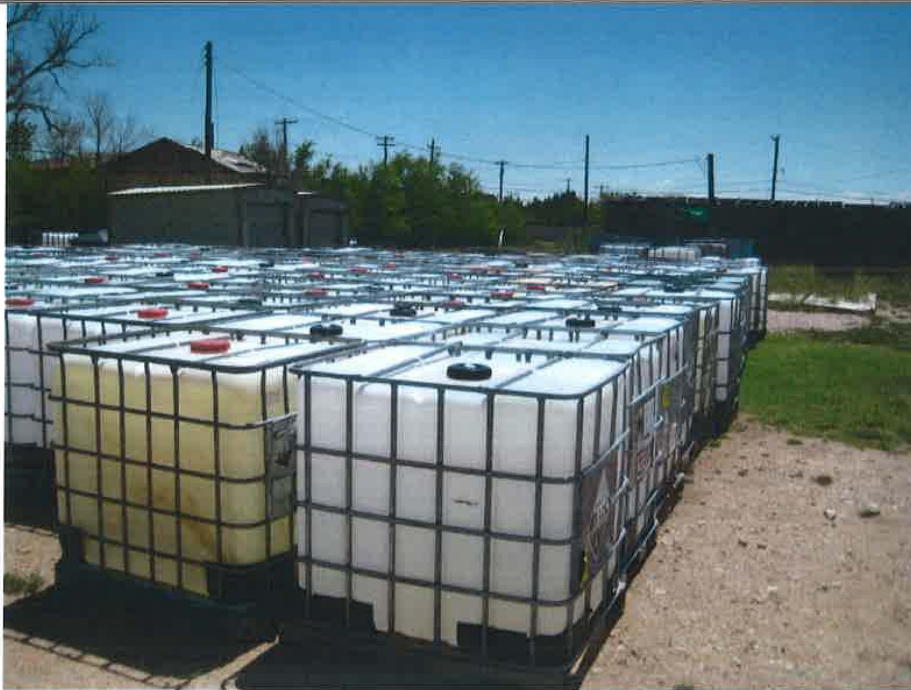
33) UNA Site

The investigators observed approximately 100 chemical totes were being stored northwest of the concrete pad (see photos 32 & 33). It is unknown if all of these totes are empty by definition. On the south end of the totes was one tote that was approximately $\frac{3}{4}$ full of an unknown waste (see photo 34). There are 4 galvanized tubs that contained water and some sort of algae growth (see photo 34 -37). It is unknown if these containers have a sealed bottom or if there is bare ground on the bottom of the tubs. There is one black plastic container that has an oily sheen on the top of the waste fluid (see photo 38). There were no lids present on the four tubs or black container. These are open to the elements and rainfall could cause the containers to overflow onto the ground. The investigators observed numerous 55-gallon drums being stored unsecured in the elements between the two storage buildings and the totes. It appeared that the drums had the lids secured except for one drum with no lid. This drum appeared to have some type of waste oil in it. None of the drums were labeled as to their contents. One overpack was observed in this area and appeared to contain some type of waste. No sampling was conducted due to safety concerns of what unknown waste was discharged on the ground with such a strong chemical/acid odor.

Looking south at chemical totes. Unknown if all totes are empty in this area.

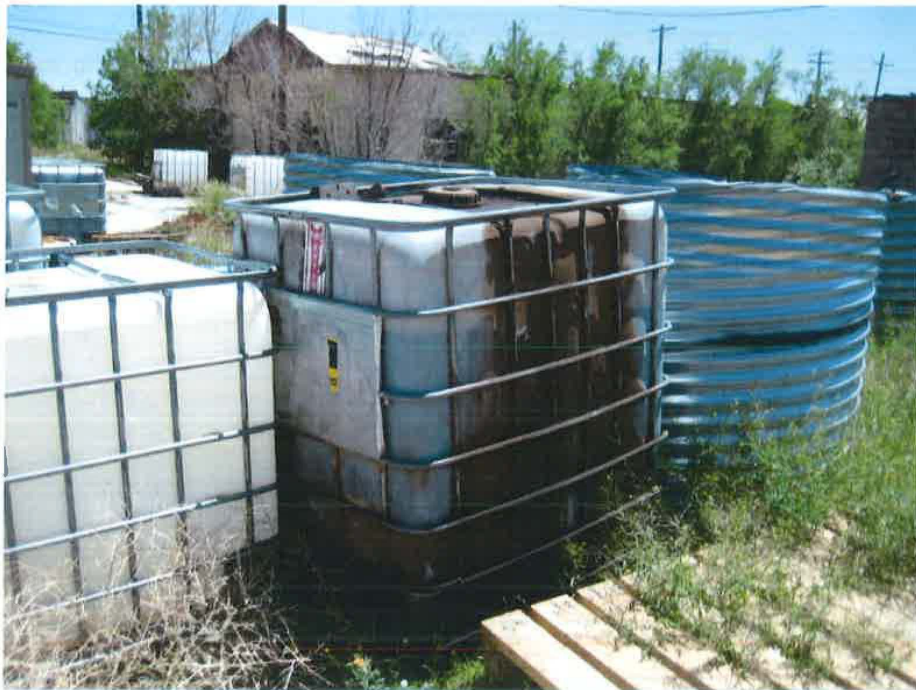
34) UNA Site

Looking southeast at chemical tote that is almost full of an unknown waste substance. The tote has leaked onto the ground in this area. The galvanized cylinders contain a liquid and it appears to be algae growing in them.

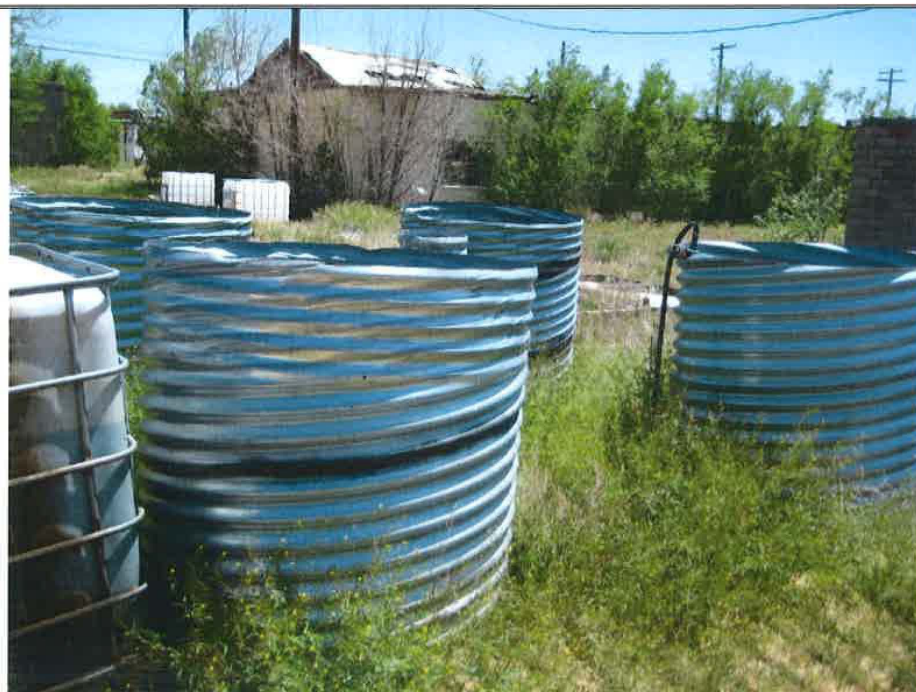
35) UNA Site

Looking southeast at galvanized cylinders containing a liquid and appears to be algae growing in them. Unknown if there is a bottom on the cylinders or bare ground.

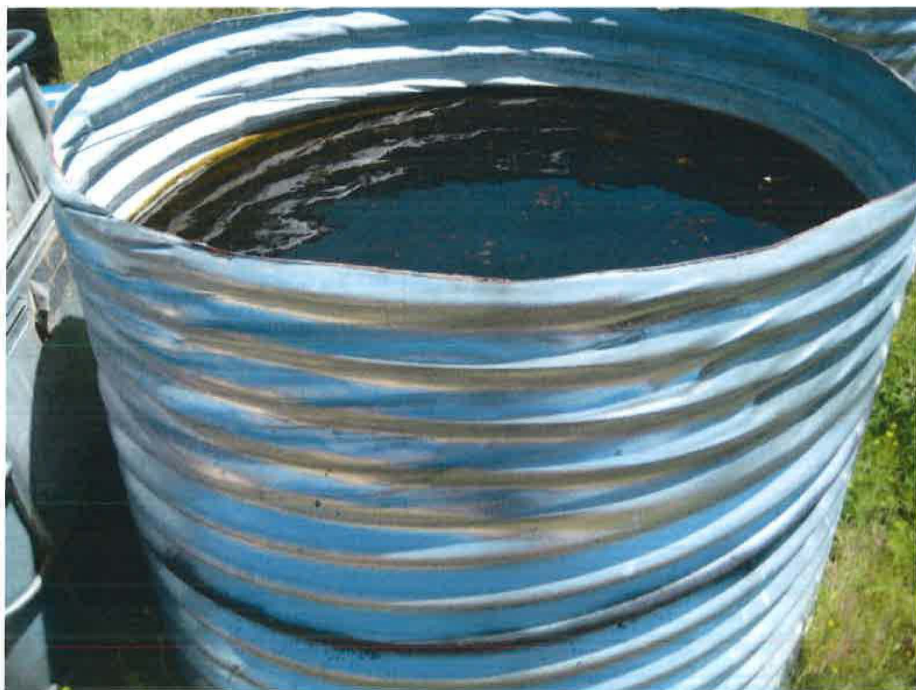
36) UNA Site

Looking at galvanized cylinder containing a liquid and appears to be algae growing in it. Unknown if there is a bottom on the cylinder or bare ground.

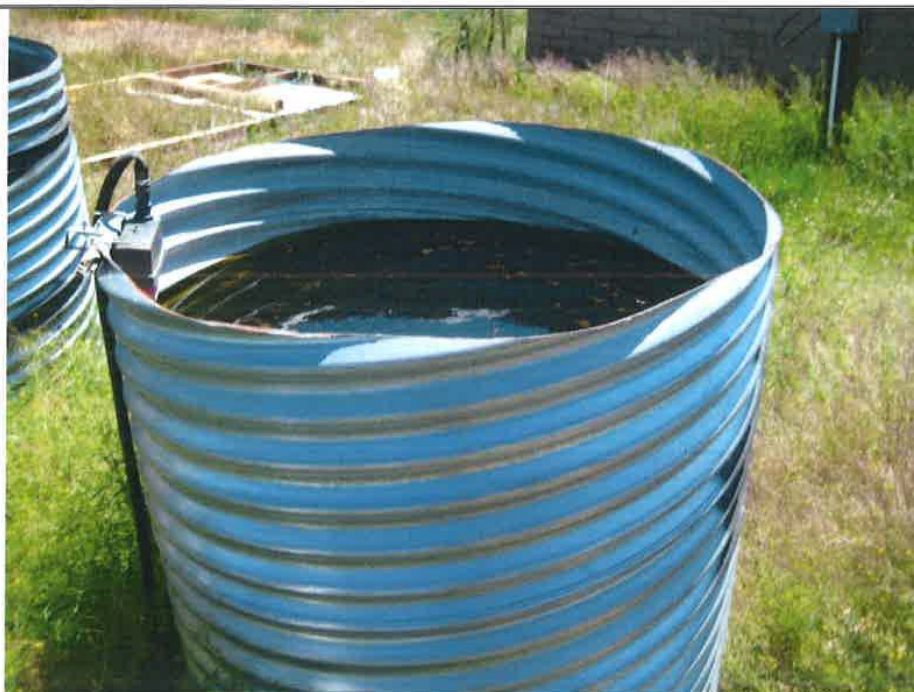
37) UNA Site

Looking at galvanized cylinder containing a liquid and appears to be algae growing in it. Unknown if there is a bottom on the cylinder or bare ground.

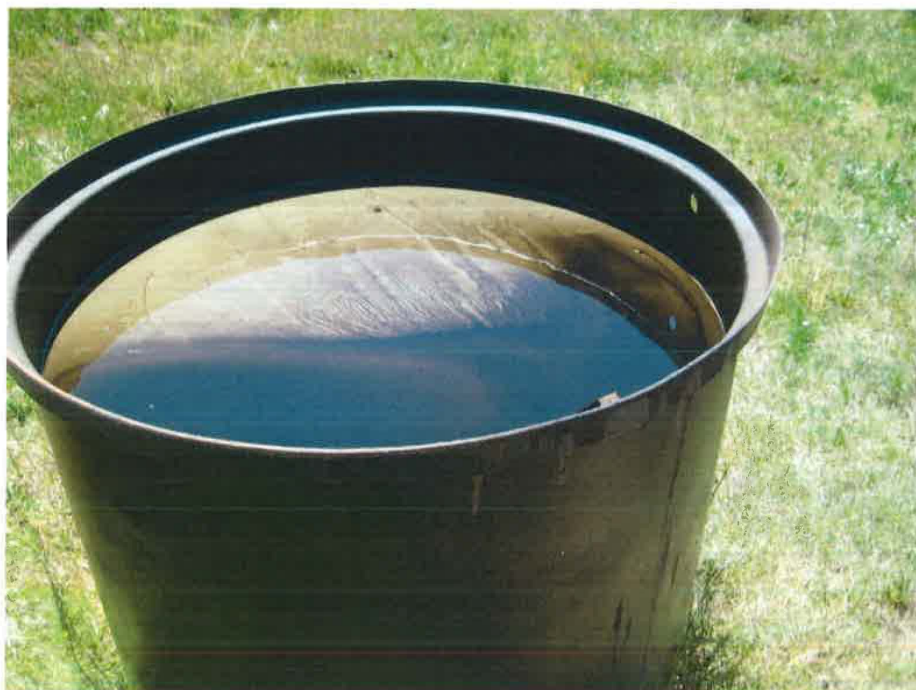
38) UNA Site

Black container that has an oily sheen on the top. The container is not closed or labeled as to the contents.

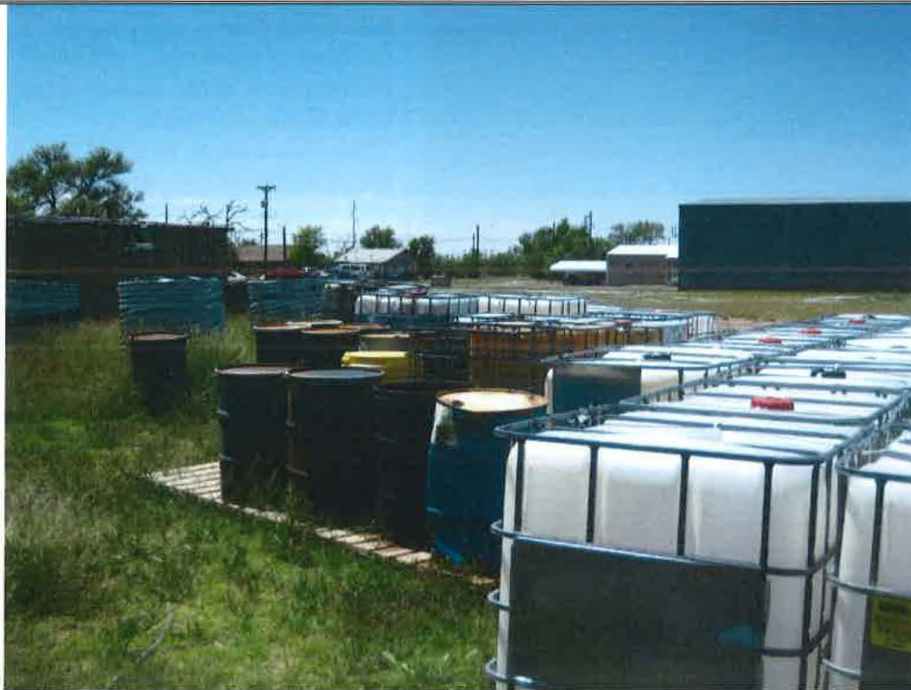
39) UNA Site

Looking southwest at chemical totes and drums. Two of the drums have no lids. The one by the blue drum has an unknown waste substance in it. It is not known what is being stored in the other drums and totes.

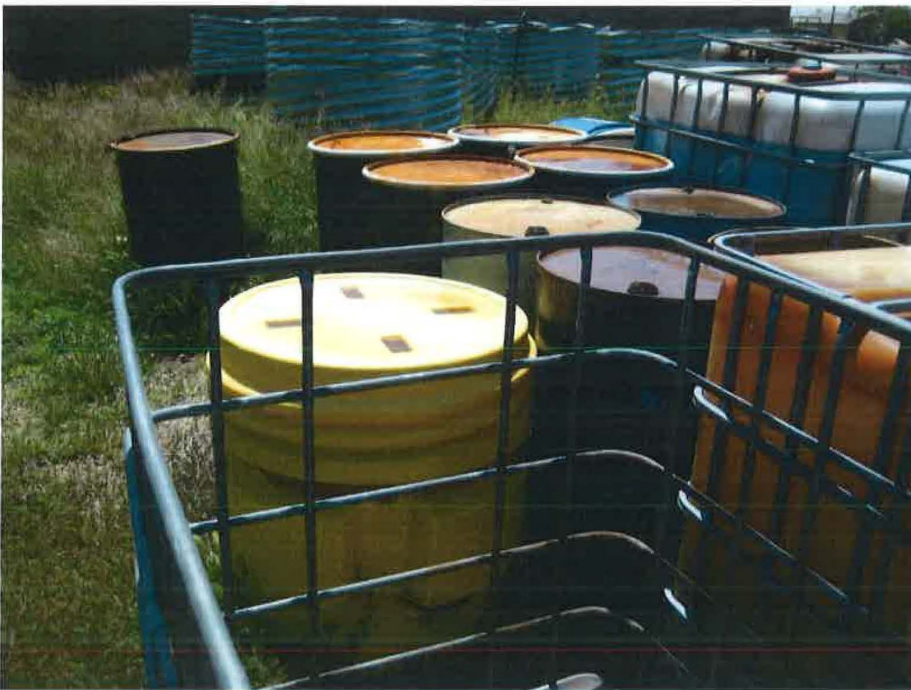
40) UNA Site

Close-up view of the drums located next to the overpack container that could be seen in photo #39. Unknown if these drums or overpack contain any waste.
